The Crystal Group, Distributions, LLC

CHALLENGE

The Department of Environmental Protection (DEP), for New York City, Bureau of Waste Water Treatment, Rockaway Plant, had a severe water incursion problem in the floor slab cold joint, located in the pump room. The constant flow of water created a safety hazard for maintenance crews working in the building. The problem was compounded due to the buildings close proximity to the Atlantic Ocean, yielding a below grade repair that presented strong hydrostatic pressure, which had caused the cold joint to fail.

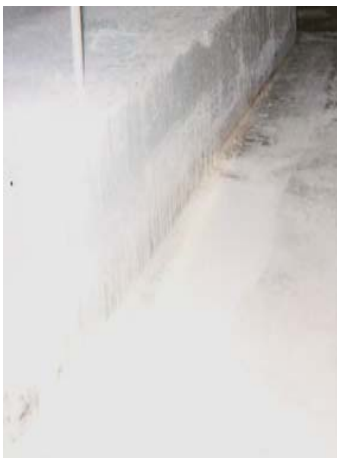
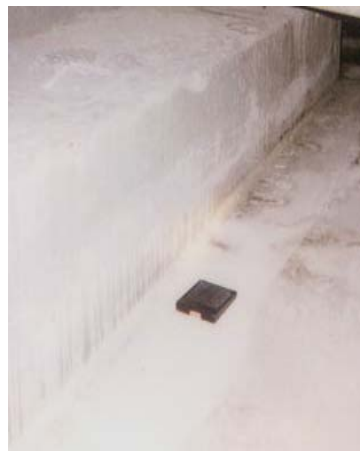
The Crystal Group installed the Kryton Krystol Technics Specification #1, crack repair system, on November 1, 2001. The cold joints were repaired, along with surface coating of the concrete using Krystol T1 and T2. This area became dry for the first time in years and to date, the system is performing flawlessly. The added benefit of KIM's self-healing capabilities for small cracks further increased the products appeal.
